PRESERVATION GUIDELINES

FOR MUNICIPALLY OWNED

HISTORIC BURIAL GROUNDS AND CEMETERIES

MASSACHUSETTS DEPARTMENT OF ENVIRONMENTAL MANAGEMENT
HISTORIC CEMETERIES PRESERVATION INITIATIVE

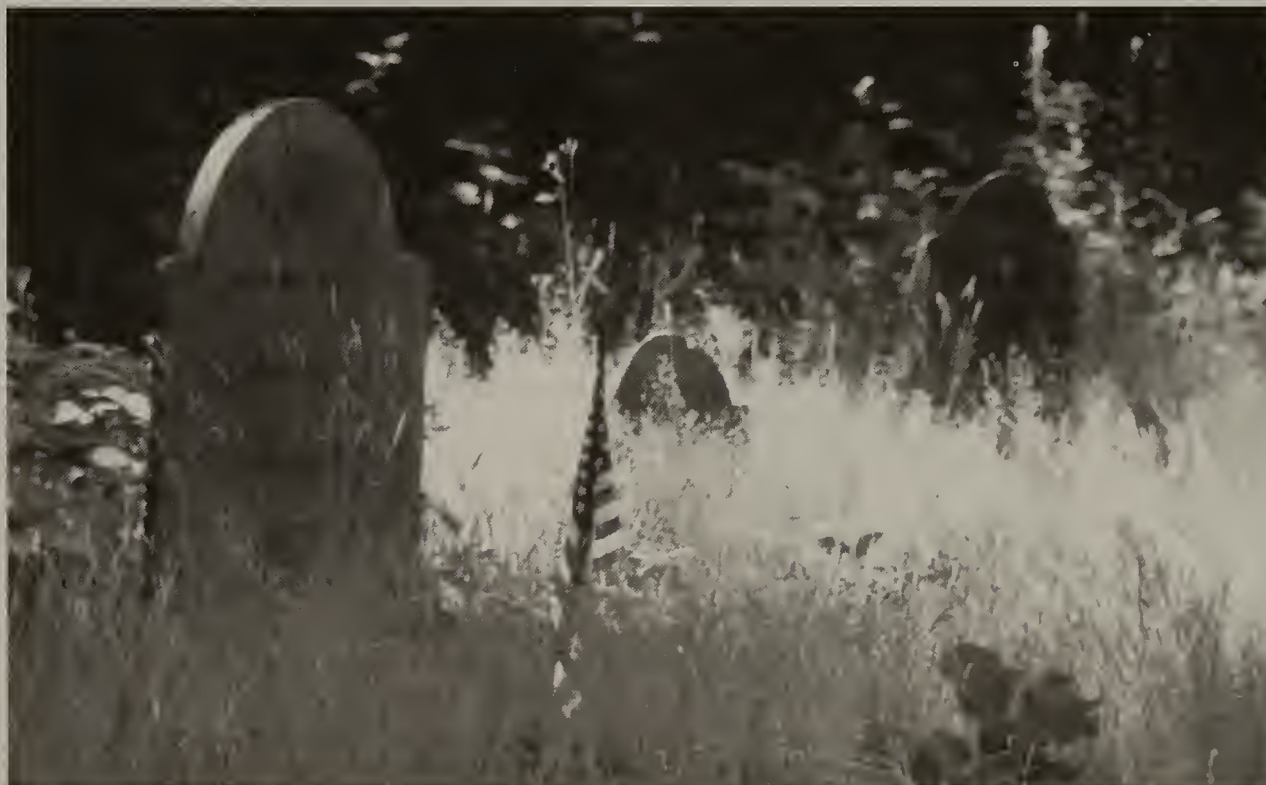
*Lawn mowed infrequently,
East Parish Burial Ground, Newton*

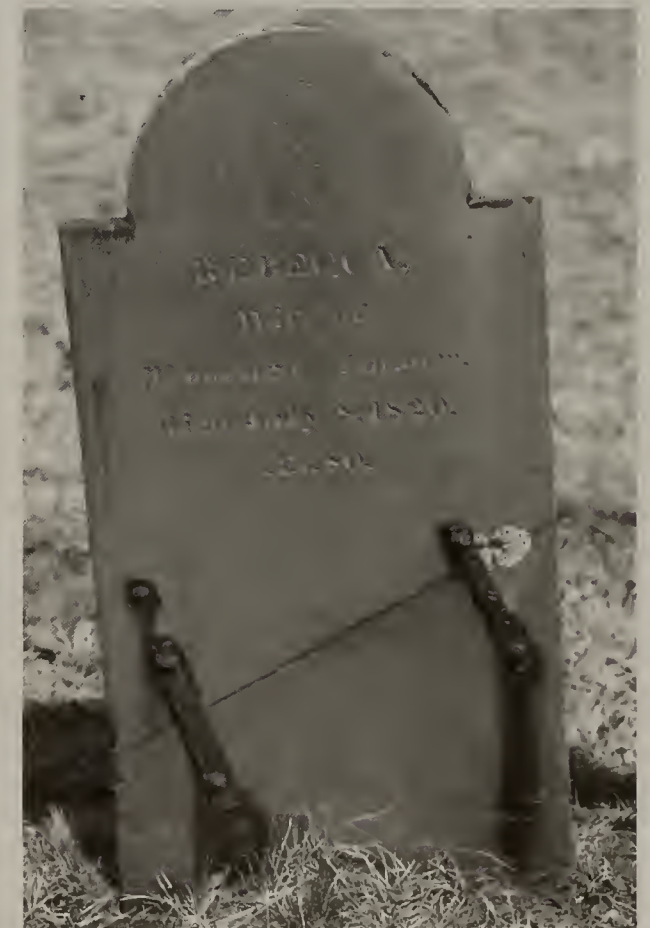
*Iron strap repair,
Old Burial Ground, East Bridgewater*

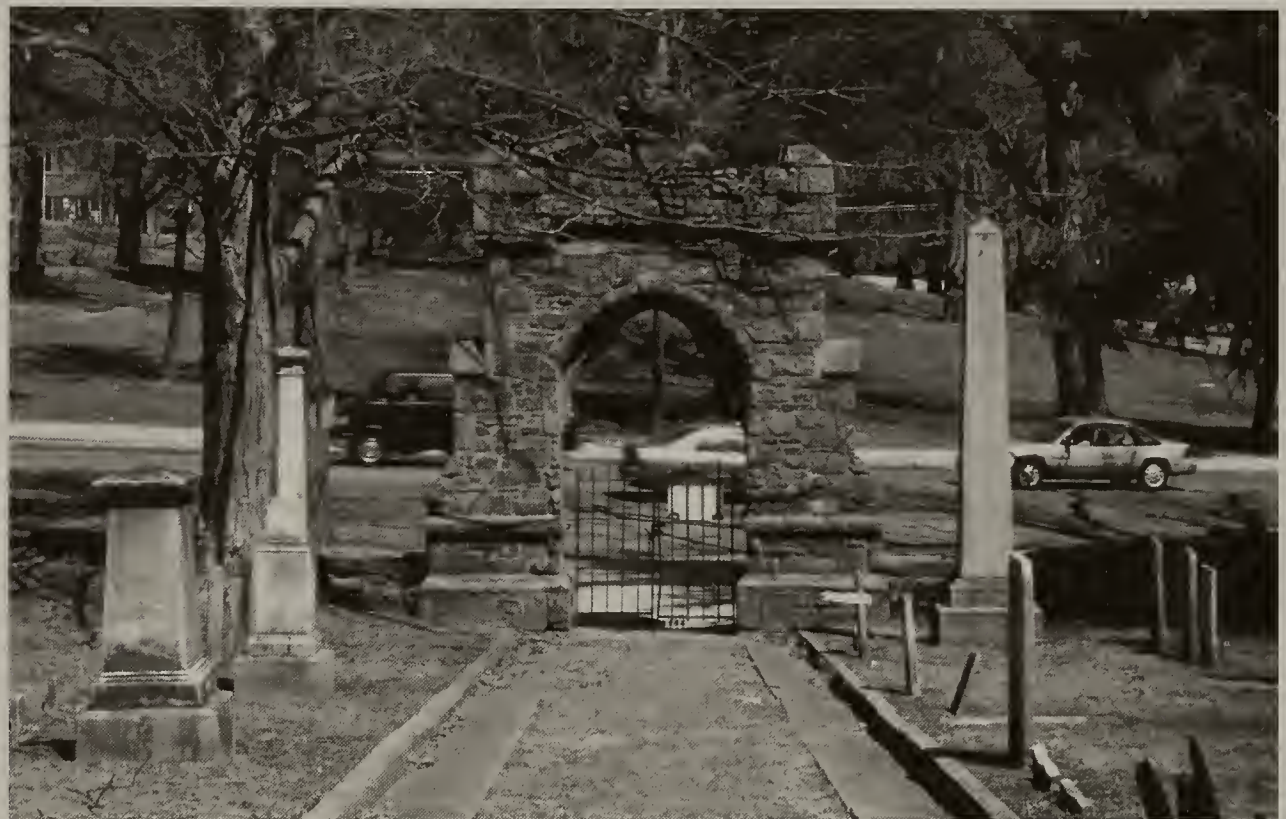
Main Street entrance arch

The 1878 Main Street entrance consists of a passage through a monumental stone arch made up of relatively small, mortared granite units, probably quarried in nearby Monson. The cut stone is coursed. The arch is in fair condition. Although there has been little, if any, shifting and displacement of the stonework, there is evidence of extensive water infiltration into the joints and behind the stones.

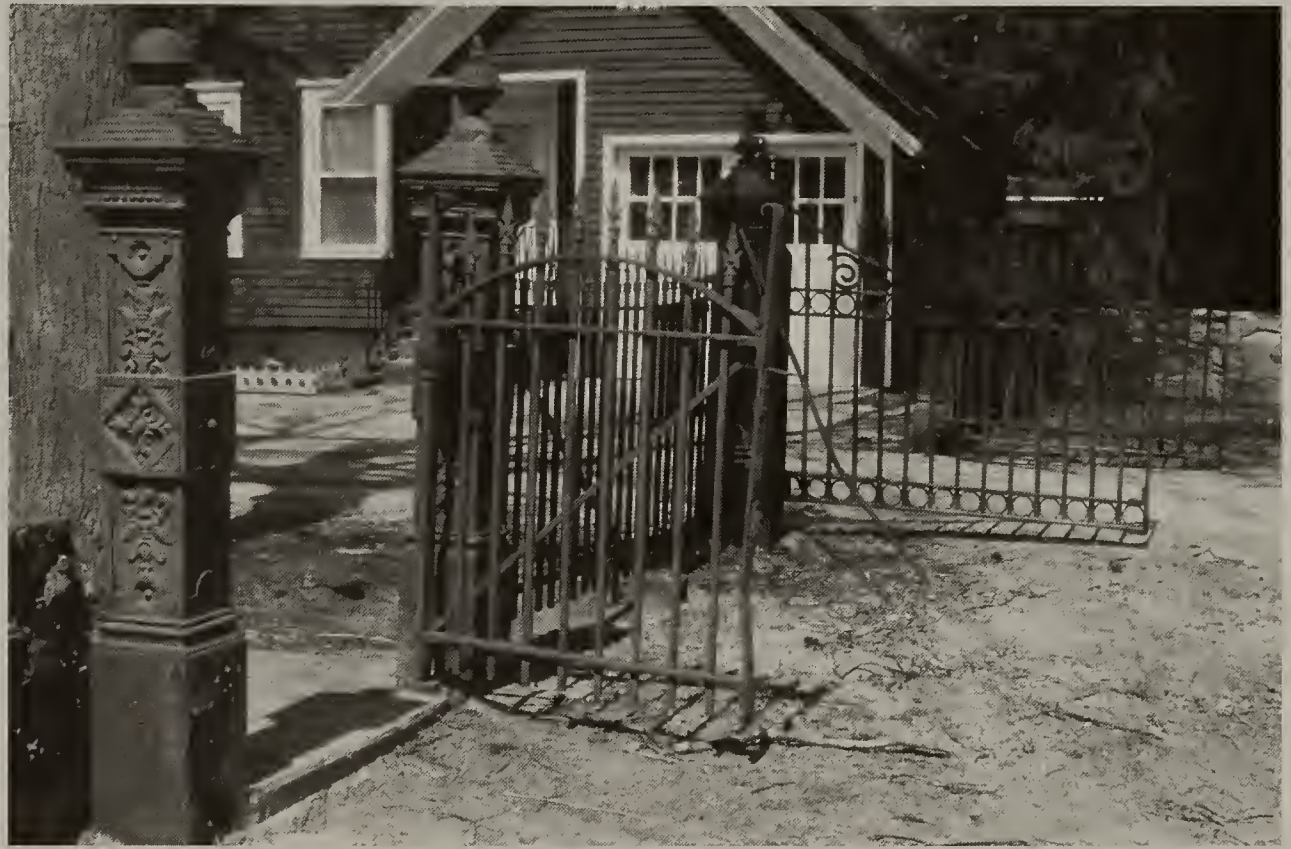
Oak Ridge Avenue entrance gate and fence

Oak Ridge Avenue Entrance Gate and Fence: This assembly consists of a green painted central double swing vehicular gate with single leaf pedestrian gates at the ends separated with an 8'-11.5" long section of fence. The north pedestrian gate is chained and welded closed. The overall assembly has 6 cast iron posts and spear headed picket fences and gates. Overall it is in poor to fair condition. The posts are made up of several cast iron pieces that snap or seat together to make up each decorative square post, base, tapering cap and finial. Damage from vehicle impact and general wear and tear have caused some of iron pieces to break or separate, such that the south vehicular gate post has been damaged and has welded repairs. It is also diagonally braced with a steel channel and bolts. The north pedestrian gate post is askew and the top is missing allowing water infiltration. Other post tops are loose or damaged. The fences are in generally good condition although a few of the spearheads are missing and some of the pickets are bent. There is also extensive corrosion and rust jacking where decorative bent bars on the gates scroll together and overlap at the bottom of the gate leaves and at the top center.
